# Manhole Inspection Summary

Manhole # S09OO\_034MH

Insp Date: **8/10/07 8:46 AM**

**Location** Address: **TROY ST ALLEY**

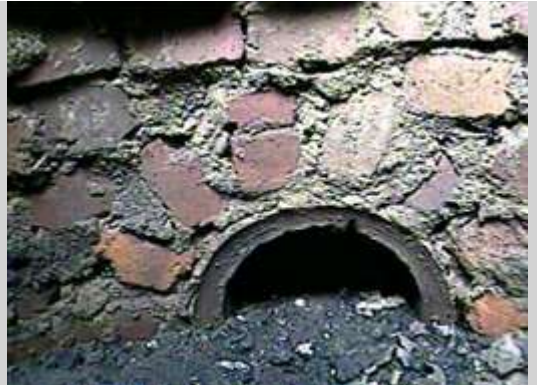
12 O'Clock Outflow

8 in. Circular Gravity Sewer  
Pipe Out @ 12 O'Clock

Deposits: ☐ None ☐ Mud ☐ Sludge ☒ **Debris** ☐ Grease

Silt Depth: **6** (in.) Deposits Extent: **Heavy**
